East Yellow Creek Recreational Use Attainability Analysis

July 2005

Prepared by:
MEC WATER RESOURCES, INC.
1000 North College Avenue, Suite 4
Columbia, Missouri 65201

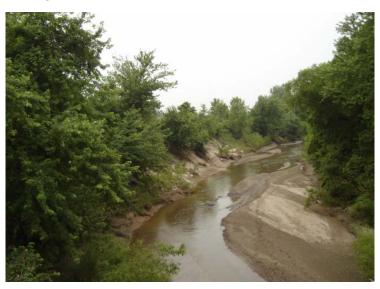
Figure 3. East Yellow Creek Site 1 Upstream View

MEC staff did not observe any direct or indirect evidence of WBCR at Site 1. MEC staff did observe trash in the form of old tires and boxes that were likely dumped from the bridge (Figure 3). Additionally, spent shotgun shells and broken clay targets were observed on the stream bank.

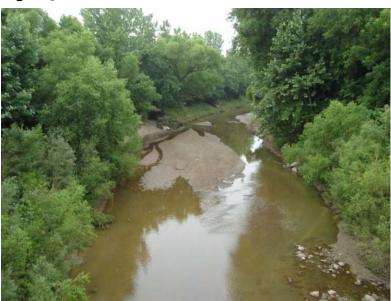
Figure 5. East Yellow Creek Site 2 Downstream View

The stream banks near the road are steeply sloping and are covered with low-growing brush and rocks (Figure 4). Riparian areas are vegetated by the upland deciduous forest complex and row crop agriculture. The stream channel was observed to be mostly sand with some cobble and gravel (Figure 5).

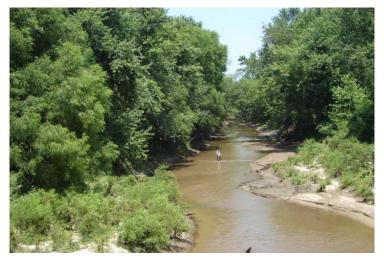
Figure 6. East Yellow Creek Site 3 Downstream View

Site 3. Road 206 Bridge Crossing (39.68226, -93.03448) 6.43 Miles from WWTF The riparian area is generally wider at Site 3 than that at Sites 1 or 2 and consists of larger trees, thick brush, and some grassy areas (Figure 6). The stream banks at Site 3 are somewhat steep and covered with rocks, brush, and downed trees (Figure 7). Stream substrate consisted of mostly sand with some mud and clay.

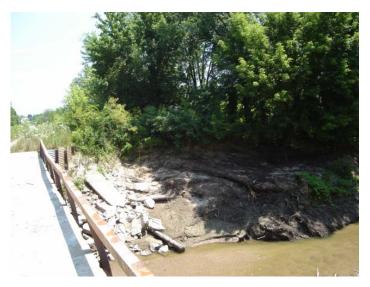
MEC staff did not observe any WBCR uses at Site 3. All terrain vehicle tracks were observed on the stream bank near the upstream section of the assessment reach. In addition to the steep bank slopes, "No Trespassing" signs were posted on land adjacent to the stream and near the access point.

MEC staff concludes that WBCR is neither an existing nor an attainable use at this site based on the low flow shallow conditions and the lack of observed WBCR uses.

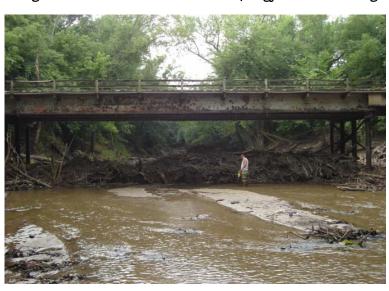
Figure 10. East Yellow Creek Site 4 Logjam Under Bridge

Site 4. Road 208 Bridge Crossing (39.66021, -93.04710) 8.88 Miles from WWTF The stream banks near the crossing at Road 208 are steeply sloping and lightly vegetated (Figure 8). Riparian areas are vegetated by upland deciduous forest and row crop agriculture. The stream channel was observed to be mostly sand with some cobble and gravel. A large pool was present downstream from the bridge and was likely due to the logjam that stretched across the stream beneath the bridge (Figures 9 and 10).
